## **Appendix B – Soil Test Pit Information**

Sheet Title: **Test Pit Locations**  
**North Street Condominiums**  
 NORTHAMPTON MASSACHUSETTS

Sheet Number:  
**TP1**

## **ATTACHMENT I**

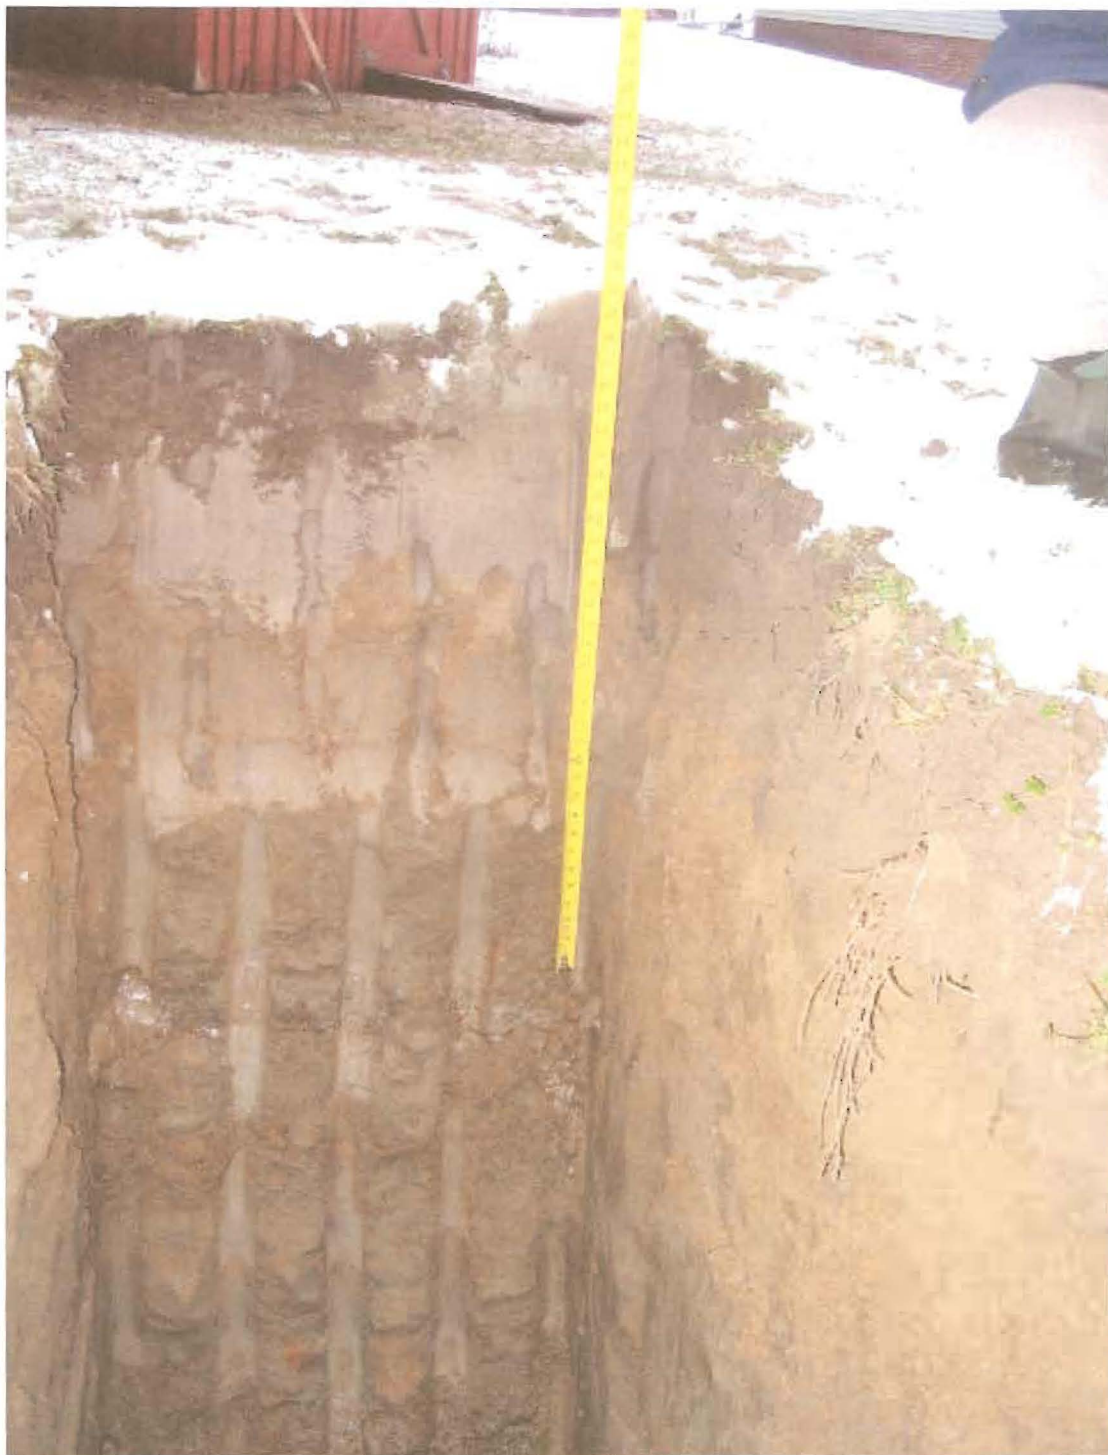
Test Pit #7  
march 9, 2009  
North street  
Northampton, MA

<b>#7</b>	0-6"	Af	Sandy Loam 10 yr 2.2	Friable f. sand, fibrous
<b>Photo</b>	6-20"	Bw	Loamy Sand 2.5 y 5.6	F. sand, mod loose & silt
	20-110"	C1	Loamy Sand 2.5y 4.4	F. sand, Little silt, w. sorted Varved, slightly massive
	110-120"	C2	C. Sand 2.5y 4.6	C. Sand, lense, well sorted.

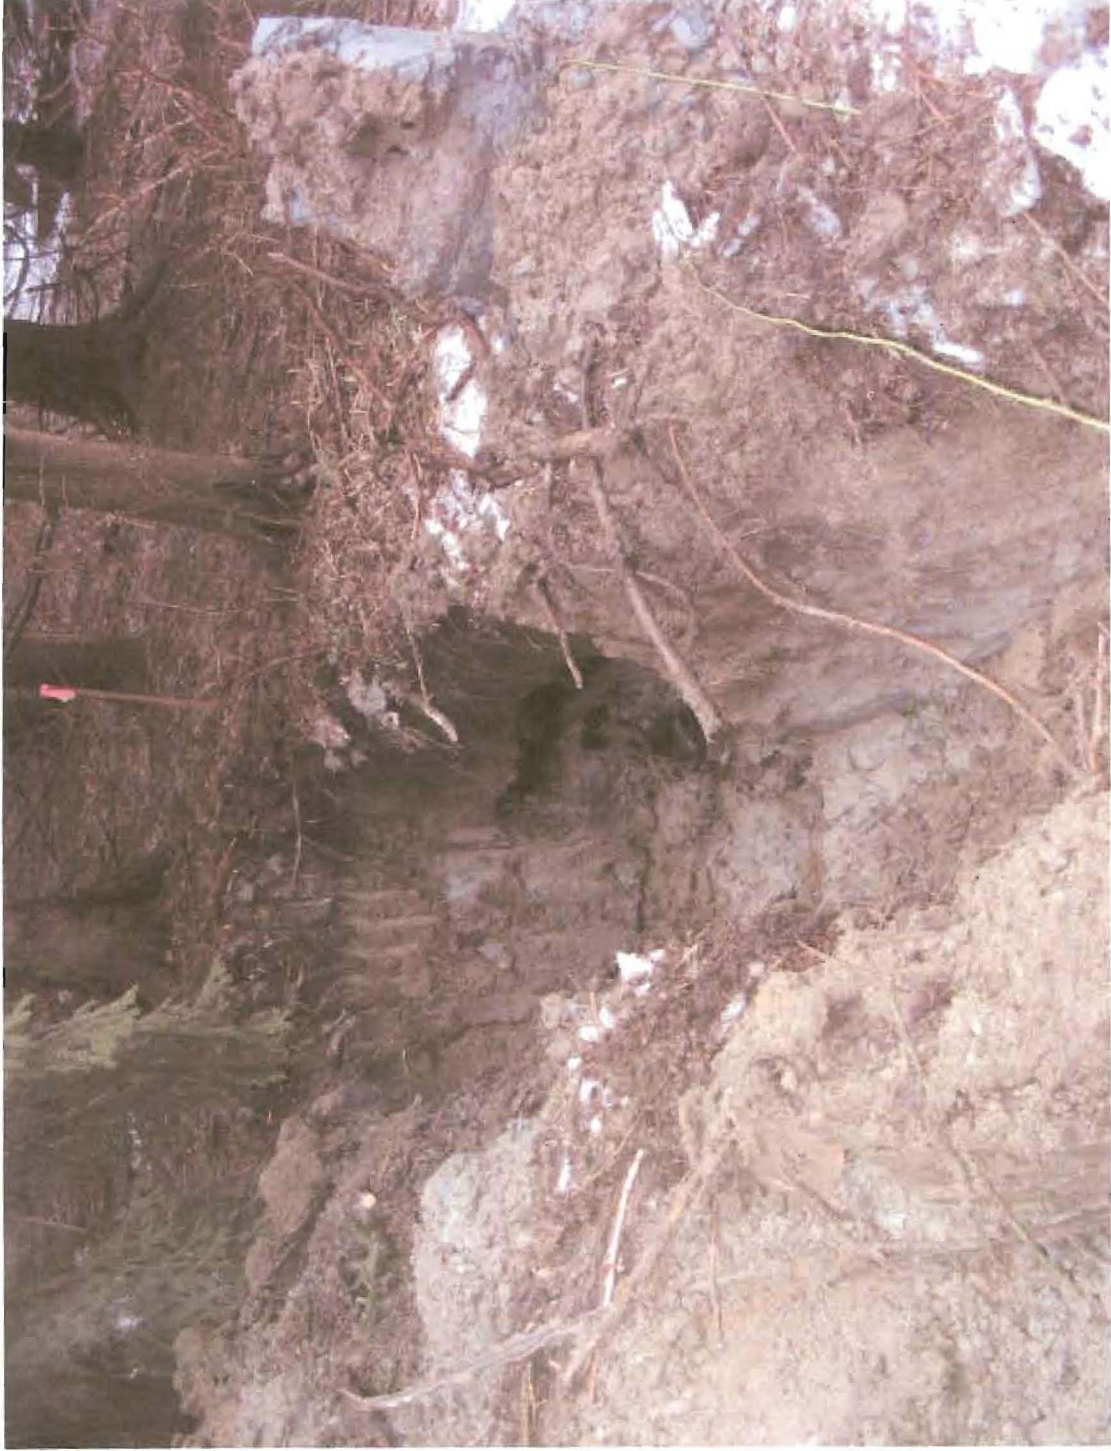
Test Pit #3  
march 9, 2009  
North street  
Northampton, MA

<b>#3</b>	0-16"	A	Fine Sandy Loam 10 yr 2.2	Moist, fibrous
<b>photo</b>	16-29"	Bw	Loamy Sand 2.5 y 4.3	F. sand, & silt, massive
	29-100"	Cg	Silt Loam 5Gy 5.1	Silt, Little Clay Varved, massive
