COLD SPRING ENVIRONMENTAL CONSULTANTS INC.

**RE: Test Pit & Soil Evaluation Results
North Street Property, Northampton, MA
CSEC Reference File #109-3106-0309**

ATTACHMENT I

Figure 1 Site Locus (USGS), Figure 2: Site Test Pit Plot

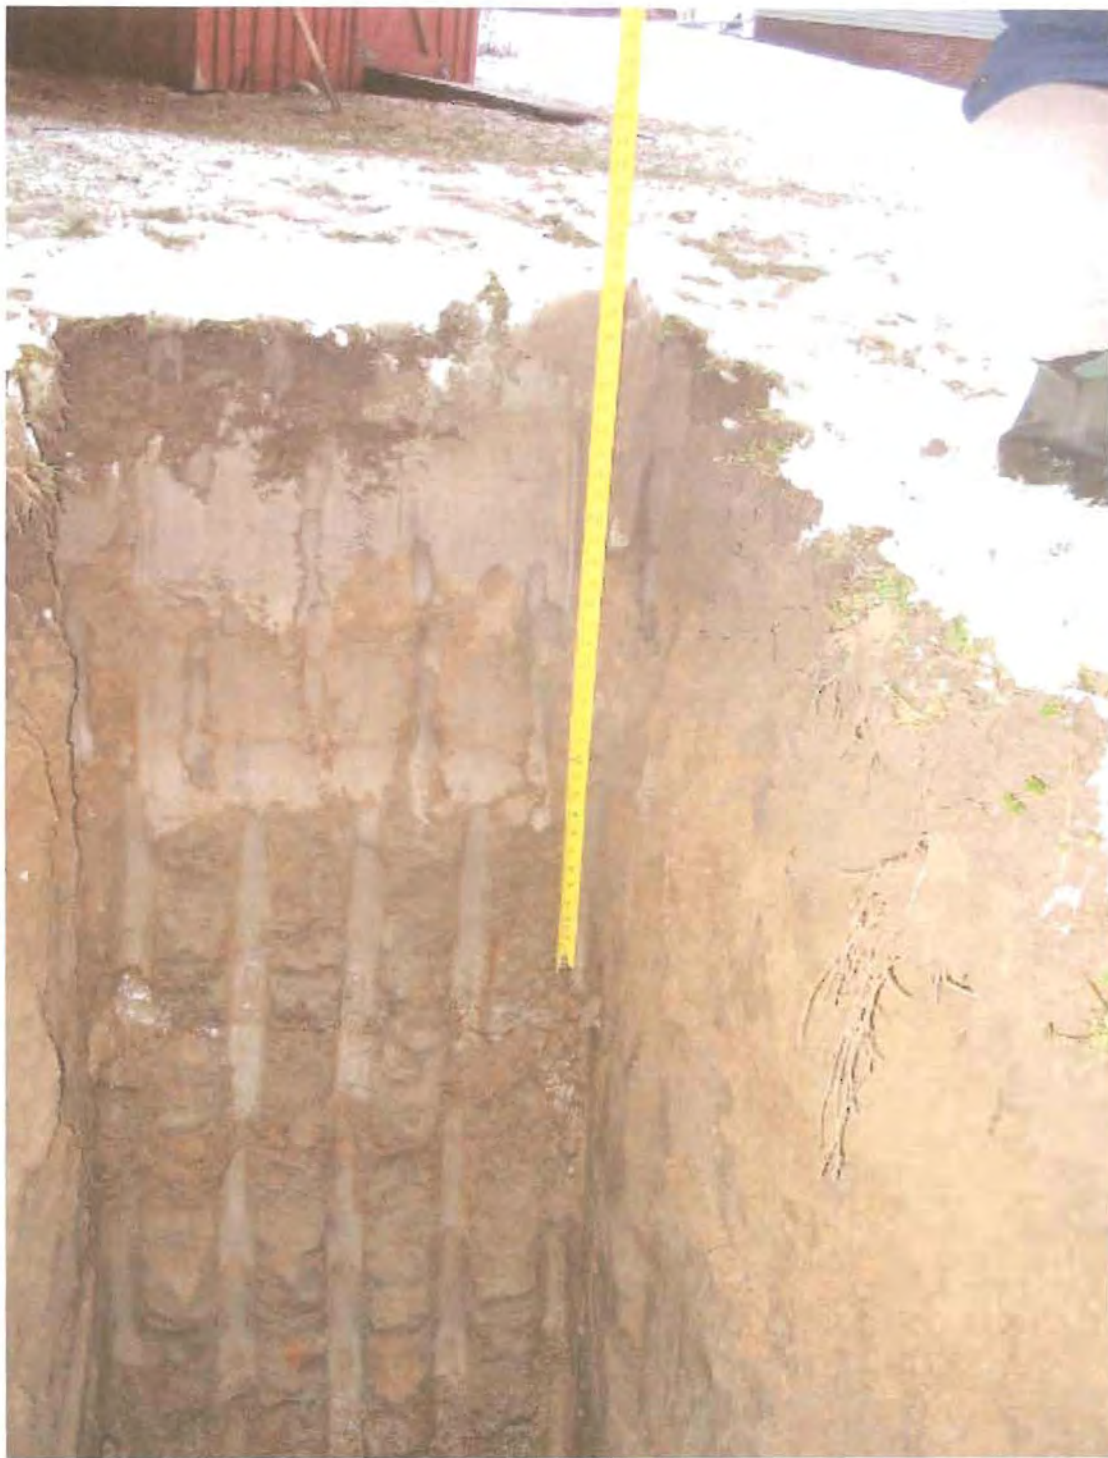
Test Pit #7
march 9, 2009
North street
Northampton, MA

<u>#7</u>	0-6"	Af	Sandy Loam 10 yr 2.2	Friable f. sand, fibrous
<u>Photo</u>	6-20"	Bw	Loamy Sand 2.5 y 5.6	F. sand, mod loose & silt
	20-110"	C1	Loamy Sand 2.5y 4.4	F. sand, Little silt, w. sorted Varved, slightly massive
	110-120"	C2	C. Sand 2.5y 4.6	C. Sand, lense, well sorted.

ESHWT = 26" (>10% strong, 2.5y 4.1&7.5 yr 5.8) Weeping=30"

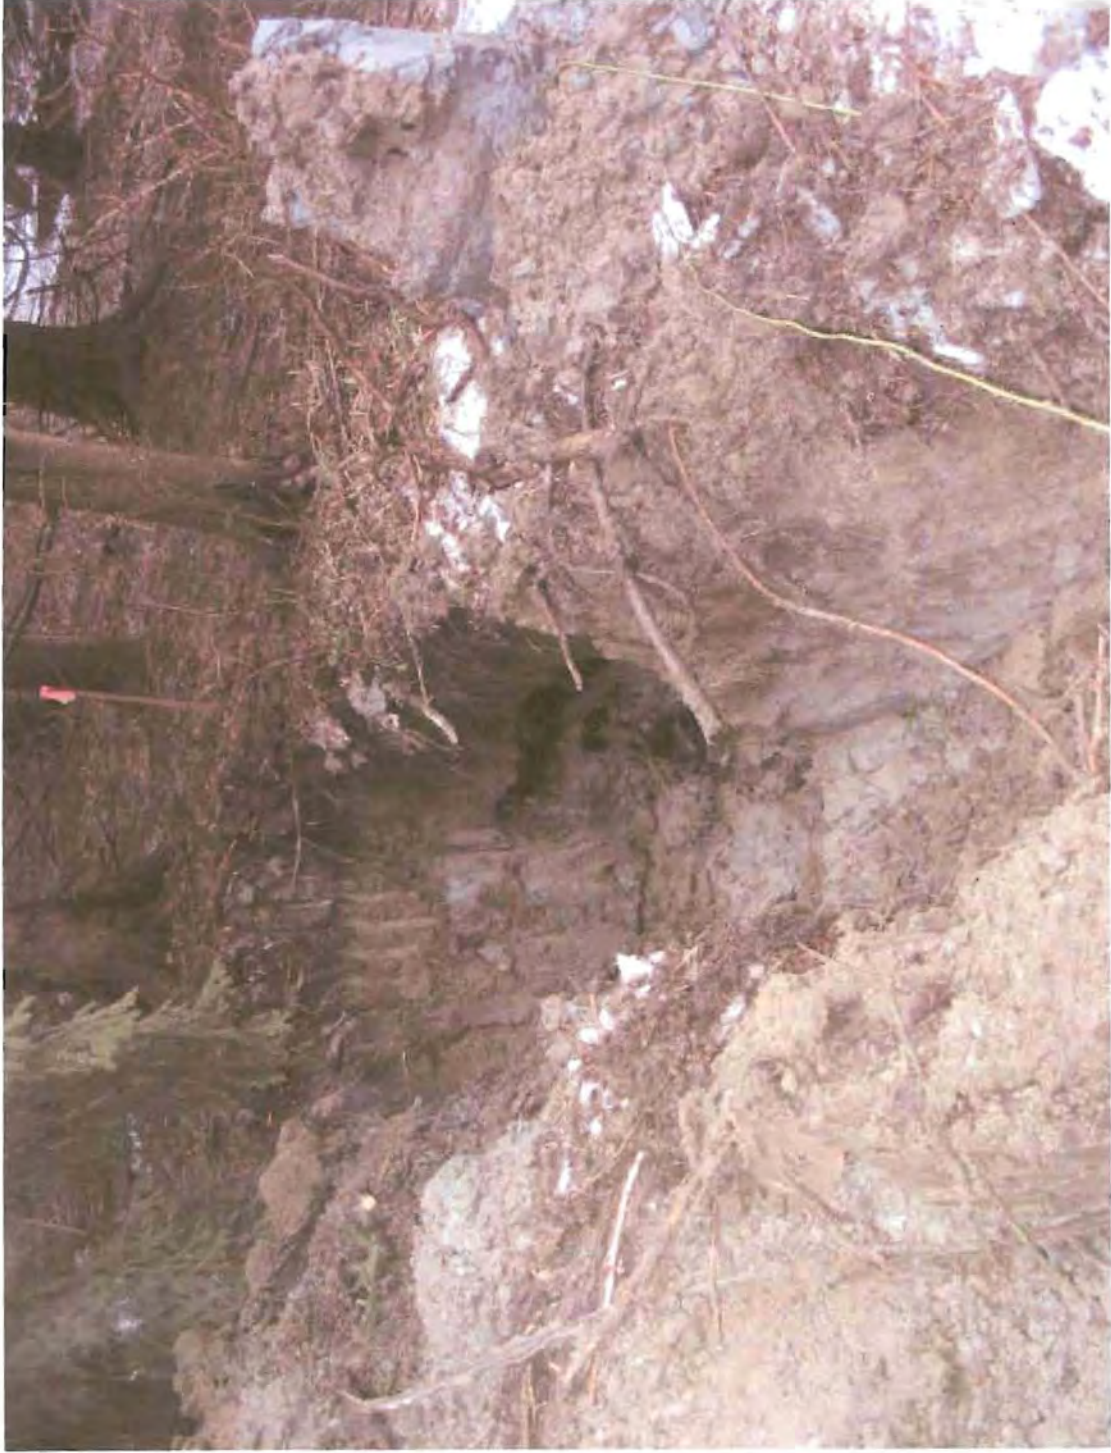
Test Pit #3
march 9, 2009
North street
Northampton, MA

<u>#3</u>	0-16"	A	Fine Sandy Loam 10 yr 2.2	Moist, fibrous
<u>photo</u>	16-29"	Bw	Loamy Sand 2.5 y 4.3	F. sand, & silt, massive
	29-100"	Cg	Silt Loam 5Gy 5.1	Silt, Little Clay Varved, massive

ESHWT = 16" (>10% strong, 5Gy 5.1& 7.5 yr 5.8) Weeping=30"
